CONNECTICUT RIVER BASIN
LEBANON, NEW HAMPSHIRE

MASCOMA DAM
NH 00155
NHWRB 134.09

PHASE I INSPECTION REPORT
NATIONAL DAM INSPECTION PROGRAM

JULY 1980

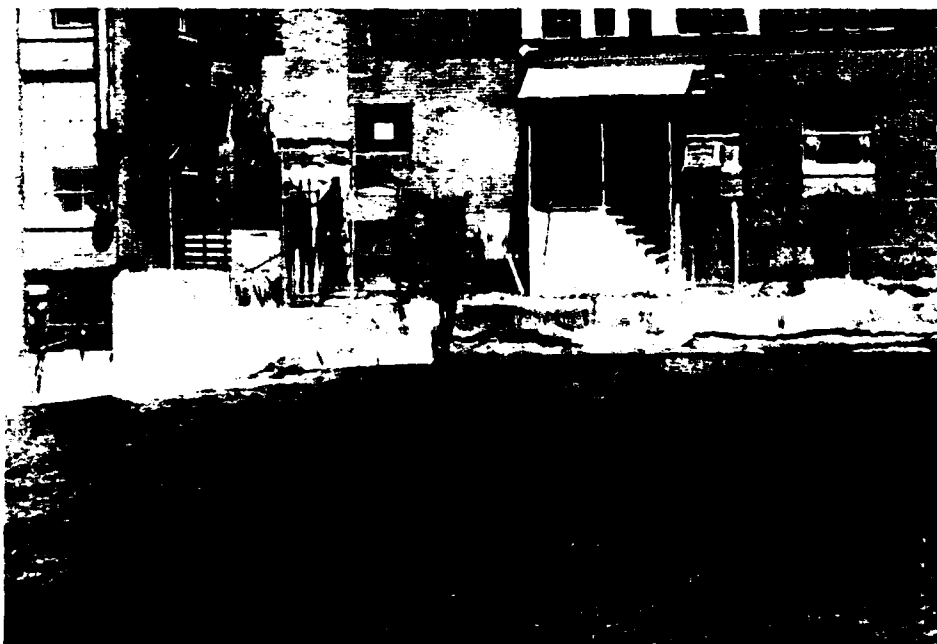
2. Right Upstream Training Wall

A sloping, galvanized steel trash rack is located immediately upstream of the timber platform opposite the forebay entrance. The platform and trash rack are in good condition. A chain link fence

located around the perimeter of the right abutment and the upstream training wall is in good condition.

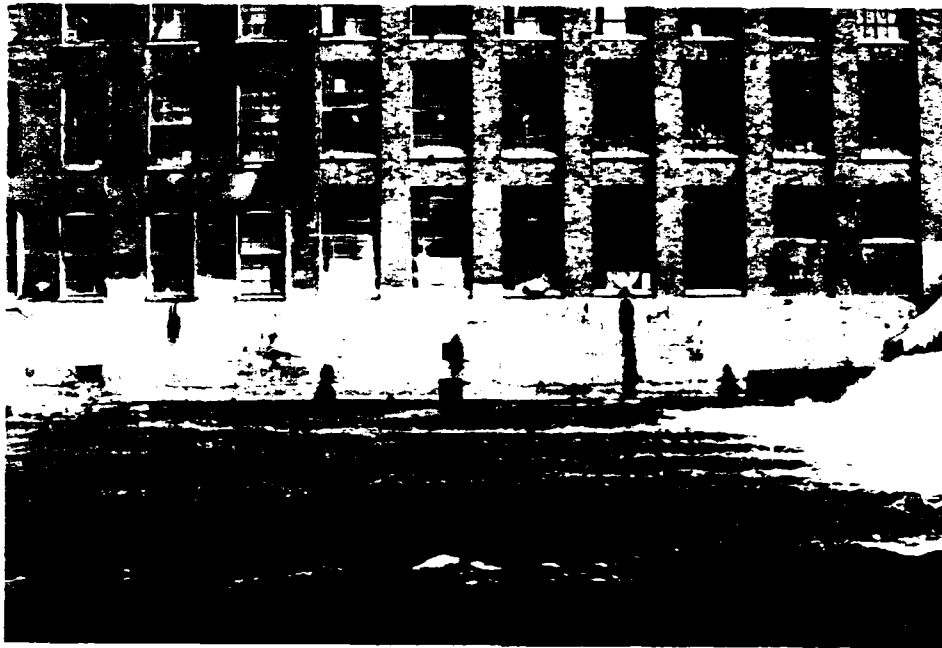
3. Downstream Outlets and Mill Building

The sluiceway outlets are 6 feet wide and 4 feet high. Saplings and other vegetative growth flourishes between the walls and the sluiceway outlets. The concrete invert of this sluiceway outlets has completely eroded exposing reinforcing steel and timber supports. The remains of the invert slab is also undermined. The bases of the end walls and dividing walls of the outlet structure are eroded up to 4 inches in height and up to 6 feet in length. The downstream side of the gate structure exhibits a high degree of spalls, open horizontal construction joints and a high degree of efflorescence. The spalling can be attributed to moisture intrusion subjected to alternate freeze and thaw cycles. Seepage is in evidence between the concrete end walls of the outlet structure and the dry stone masonry walls.

At the right abutment of the dam is a mill building which lines the stream just below the dam. A gated inlet just upstream of the mill building leads to power generating equipment inside. The building's windows facing the stream are roughly 11 feet above the streambed. A single story expansion of this building downstream sits on the right stream bank and could be subjected to flood damage. The floor level is approximately 9 feet above the streambed.

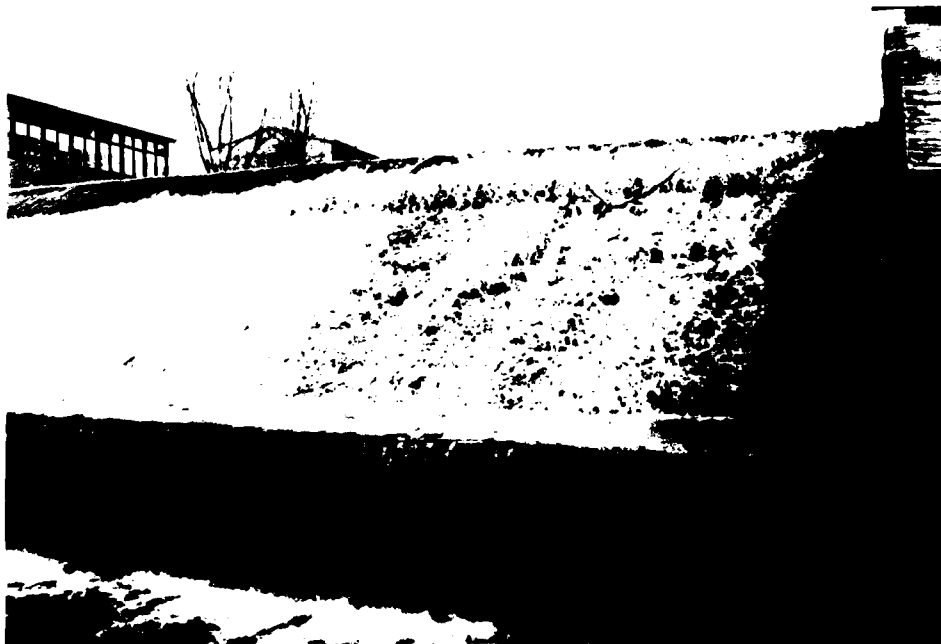
4. Right Spillway Section

This structure is in deplorable condition as evidenced by severe erosion, exposure of formerly concrete faced timber cribbing and settlement. There is a large horizontal crack and settlement over the entire downstream face of the spillway 2 to 3 feet below the crest. In addition to the foregoing there are numerous horizontal cracks and holes resulting from cavitation.

Approximately 20 feet of the left end of this structure has been subject to such a high degree of cavitation and ice damage that large rubble stones have been exposed. The entire downstream sloping surface has settled in excess of 6 inches and possibly in excess of 12 inches. The actual degree of settlement could not be determined due to the overflows. A 5 foot wide concrete faced platform supported on a timber crib is located on the downstream end of this structure. The top of this platform is approximately 4 feet above the tailrace channel. The concrete surface has been subjected to considerable erosion which can be attributed to ice damage. The downstream end of this concrete platform has been shattered exposing the timber crib. Observations have revealed that the crest is not level; the left portion being lower than the right. It was also observed that the right end of the downstream platform is lower than the left.

- (a) Severe cracking and toppling of the training walls and general poor condition of the waste gate structure.
- (b) Severe erosion and general poor condition of the right timber crib spillway section.

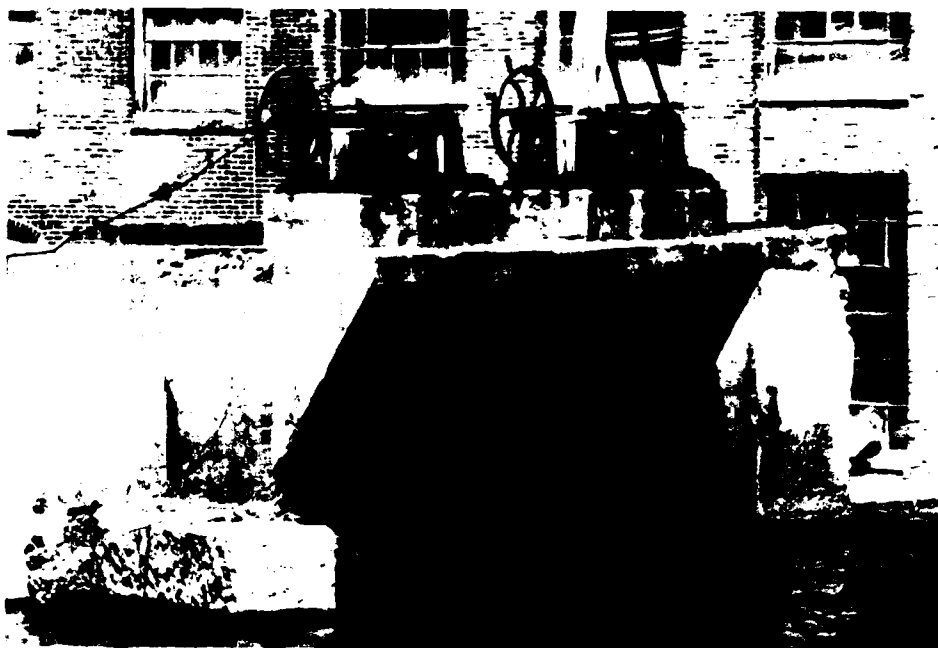
7. Upstream View of Waste Gate Structure

The top upstream right and left corners have been subjected to a high degree of spalling. This spalling is in excess of 6 inches in depth. The concrete platform which supports the gate bench stands is cantilevered over the impoundment pool by approximately 3 feet by means of 4 concrete brackets. The platform itself is in good condition.

The manually operated gate mechanisms consist of hand wheels and worm gears which actuate the rack gears on the timber stems. The operating mechanisms are severely rusted. In 1978 they were raised for a height of 8 inches with considerable effort. The timber sluice gates are in good condition and well seated with minor seepage flowing around the gates.

downstream warning system, clearing saplings and soil from behind waste gates, cleaning and lubricating waste gate operating mechanisms, and repairing concrete and masonry.
